**Property Address:** 397 E Lorna Ln, Camano, WA 98282

Standard Full Home Inspection

## Standard Full Home Inspection

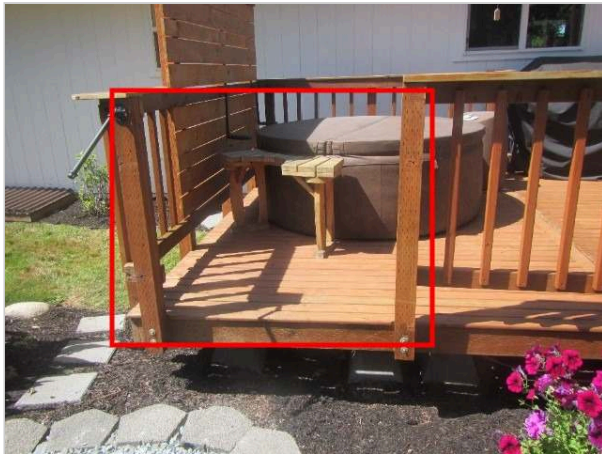
The back deck has a section of railing that was missing at time of inspection. Lack of proper banisters and railings are a major cause of household accidents. Our standard of practice recommends that all elevated decks and patios have sturdy protective banisters and railings, if they are more than 18" high. Replacing the missing railing is suggested, as a preventive safety measure.

*The back deck has a section of railing that was missing at time of inspection. Lack of proper banisters and railings are a major cause of household accidents. Our standard of practice recommends that all elevated decks and patios have sturdy protective banisters and railings, if they are more than 18" high. Replacing the missing railing is suggested, as a preventive safety measure.*

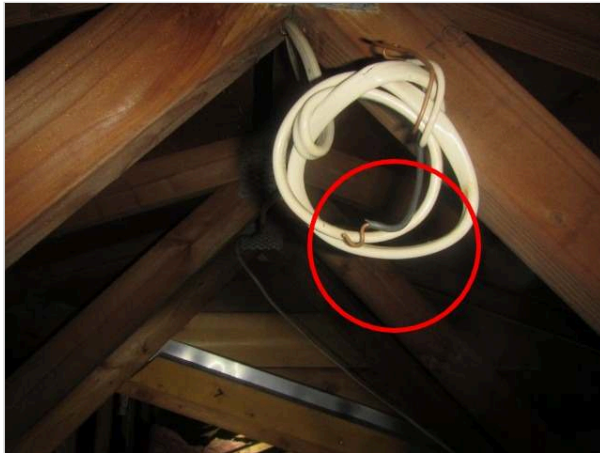
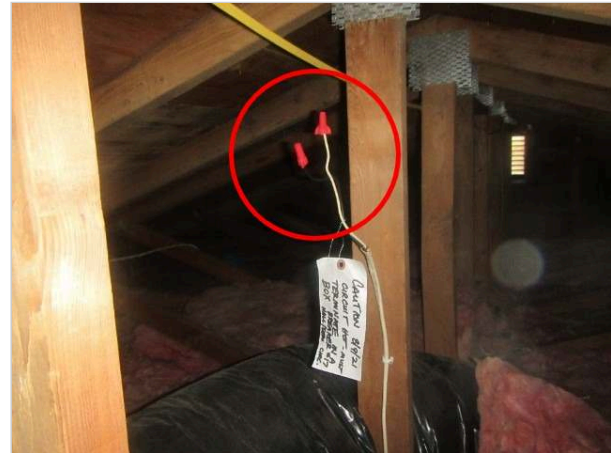
There are wire ends in the attic that should be secured with wire nuts and placed within a junction box. Further review and repair by a qualified contractor is suggested.

*There are wire ends in the attic that should be secured with wire nuts and placed within a junction box. Further review and repair by a qualified contractor is suggested.*

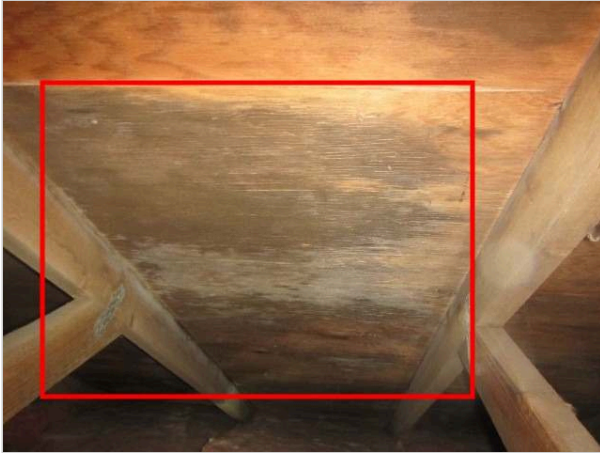
A small amount of organic staining on the roof sheathing boards was visible at time of inspection. This condition is usually caused by poor attic ventilation and/or by excessive moisture entering the attic area. The staining/organic growth will not continue to be active if the moisture issues are resolved. This inspector is not a certified mold inspector and if further information is desired, it is recommended that an individual with this specialty be contacted for further evaluation. The inspector believes the staining is caused by poor/missing attic ventilation. Further review and repair by a qualified contractor is recommended.

*A small amount of organic staining on the roof sheathing boards was visible at time of inspection. This condition is usually caused by poor attic ventilation and/or by excessive moisture entering the attic area. The staining/organic growth will not continue to be active if the moisture issues are resolved. This inspector is not a certified mold inspector and if further information is desired, it is recommended that an individual with this specialty be contacted for further evaluation. The inspector believes the staining is caused by poor/missing attic ventilation. Further review and repair by a qualified contractor is recommended.*

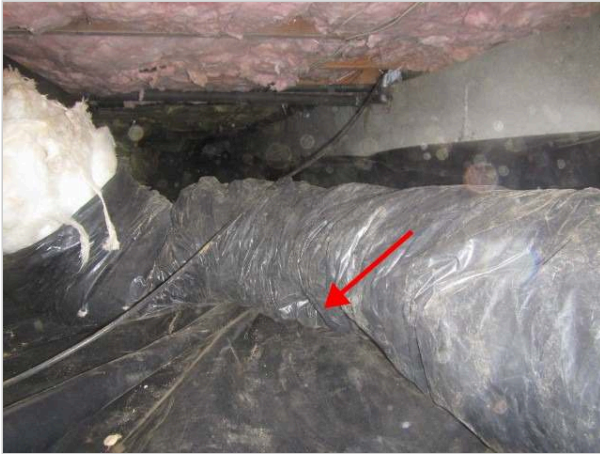
There is ducting visible in the crawl space that is not properly supported and is in contact with the ground. The direct ground contact may cause the duct to deteriorate and fail over time. Further review and repair by a qualified contractor is suggested.

*There is ducting visible in the crawl space that is not properly supported and is in contact with the ground. The direct ground contact may cause the duct to deteriorate and fail over time. Further review and repair by a qualified contractor is suggested.*
